CASE STUDY

CEMENT TRANSPORT IN PORT BRISBANE

THE ESSENTIAL AIR SEAL DUST CONTAINMENT COMBINATION

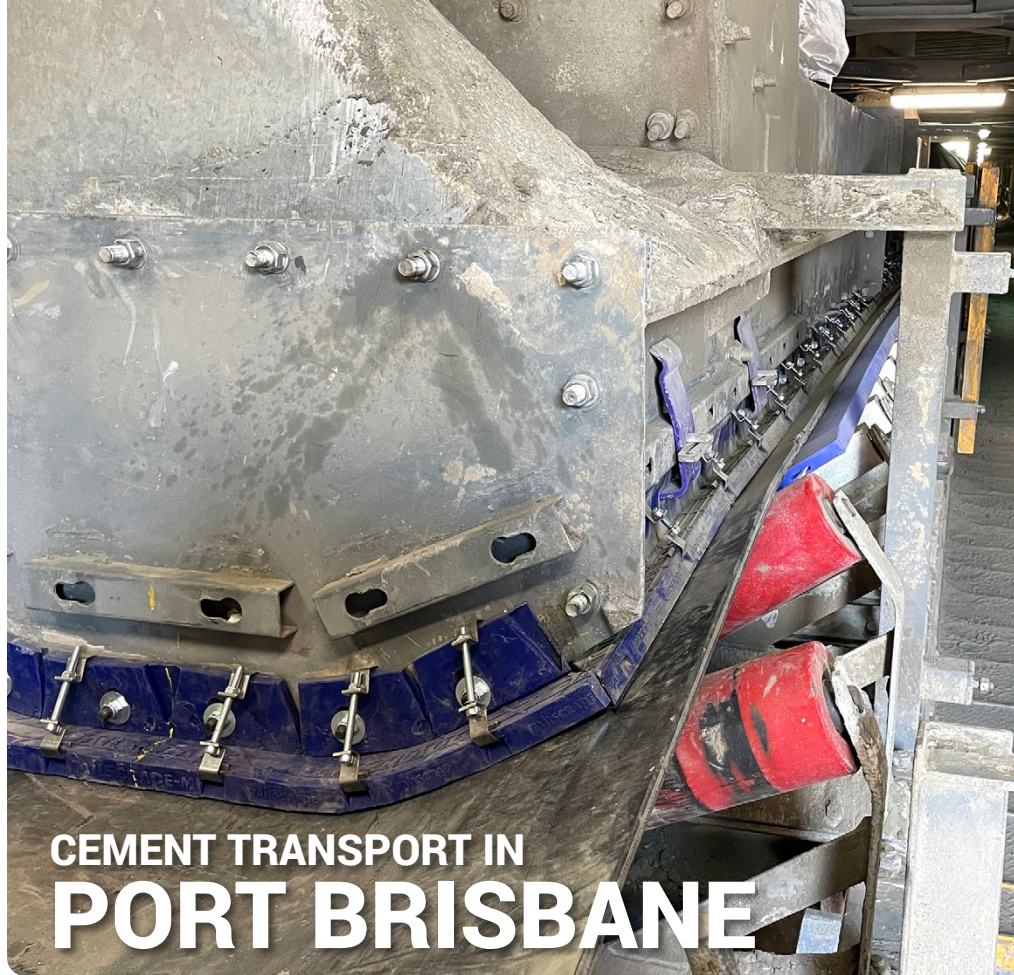
- excessive dust emissions, posing major OHS issues
- target material spillage
- belt support and belt sag issues
- minimizing production shutdowns

- dust and material spillage reduced by 98%
- no belt damage
- no future adjustments
- no future maintenance
- exceed product performance expectation
- more upgrade opportunities in other transfer points

8 m [AirScrape](#)

1 m [Tailscrape](#)

6 m [SureSupport](#)

8 m [FRAS K-Containment® Seal](#)

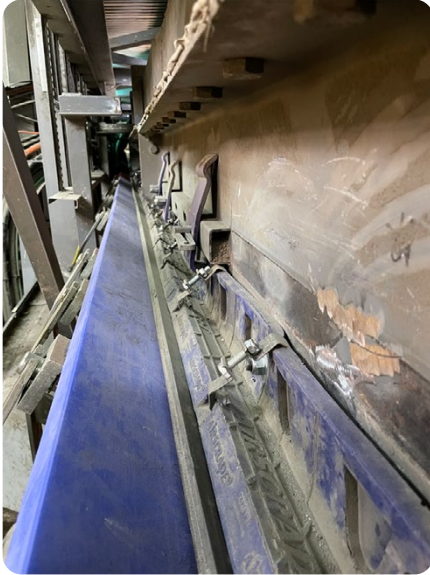
Installation of AirScrape together with SureSupport. This combination improves material absorption and ensures optimum tightness.

To ensure maximum performance of AirScrape®, SureSupport Belt Support System, a vital component of the overall solution was installed in order to avoid the issues of belt sag between the impact rollers.

A smooth straight and flat belt surface kept the AirScrape® lamellas continuously in the right position with no physical belt contact. TailScrape® worked synergistically with AirScrape® and provided outstanding sealing at the rear and ST-Containment Seal delivered on its promise as the first line of defence and effective against dust and spillage. Maintenance teams are also thrilled to report, prior to the phase 2 recommended installation, there was extremely poor visibility of the tail end of conveyor from the head chute. With dust and spillage under control visibility along the 70-metre-long conveyor is now vastly improved. "The Essential AIR Seal, Dust Containment Solution is a huge improvement in comparison to our initial setup, no belt damage and no ongoing maintenance is required," reported by Site Manager.
