CASE STUDY

TRANSPORT OF WHEAT & BARLEY IN QUEENSLAND, AUSTRALIA

Customer makes a wise decision in favor of the new and innovative ScrapeTec and KINDER sealing technology with positive results.

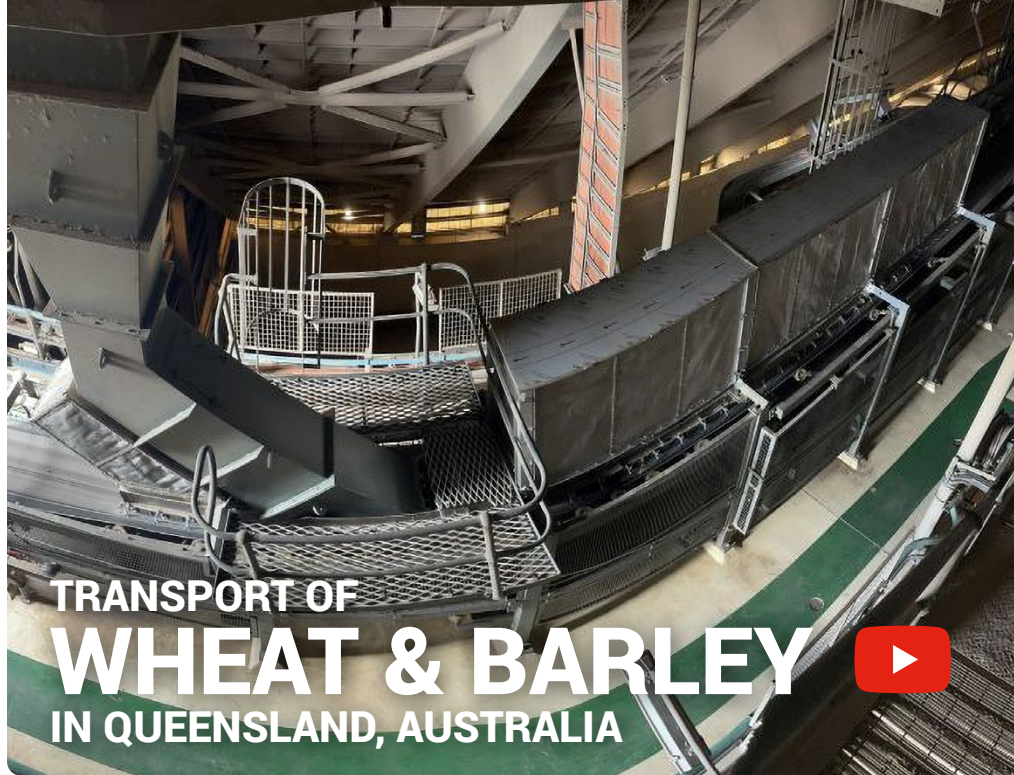
- Excessive dust and spillage at the transfer chute.
- Slippage and other OHS hazards linked to dust/spillage issues.
- Anti-static/FRAS requirements.

Due to high material drop at the transfer chute an excessive amount of dust and spillage was observed. Faced with the ongoing dust and spillage predicament, the Maintenance Supervisor specifically sought a low maintenance, long lasting solution to suppress and minimise the excess dust/spillage at the facilities outdated tail end transfer chutes.

The operator previously relied on double sealing skirtings which were worn through, the chute set up was also outdated and well due for an overhaul.

- 10 m [AirScrape](#)
- 1 m [Tailscrape](#)
- 15 m² [DustScrape](#) filter surface
- 10 m [FRAS K-Containment® Seal](#)

AirScrape® (10 m), FRAS TailScrape (1 m), and FRAS K-Containment® Seal (10 m) and extension of the existing chute tunnel and custom made Dustboxes. Behind the drop chute, the Tailbox was extended by 1-metre. Stainless steel filter cloth was also installed onto the Tail Dustbox.

In front of the chute tunnel, a 6-metre long, 1.2-metre high and 0.6-metre-wide a custom-made Dustbox with stainless steel filter cloth was also installed. The filter cloth is vertical, left and right side of the Dustboxes, nothing on the top, the end and the front of the Dustbox. Inside the Dustboxes, 5 dust barriers and curtains were installed to further calm down and suppress the excessive dust clouds. Similar to the Tailbox, the excessive air pressure gets released through the vertical stainless steel filter clothes, dust is successfully contained inside the Dustbox and drops back into the material stream.

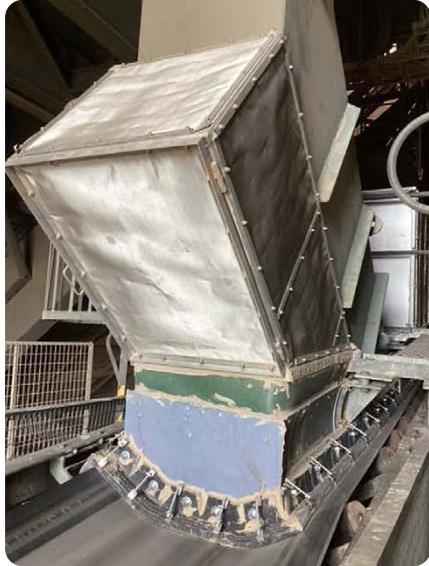
Between January and April 2023, the installation process began, this entailed modifications to the drop zone to divert the grain/barley to be more centrally loaded. The site skirting was also modified to accommodate Kinder's FRAS

The excess dust has been successfully contained and soiling has now been reduced to zero.

With the reduction in air pressure, dust and/or material was no longer able to escape from the Tail box. Excessive air pressure gets released through the filter cloth, the dust stays inside the box and drops back into the material flow.

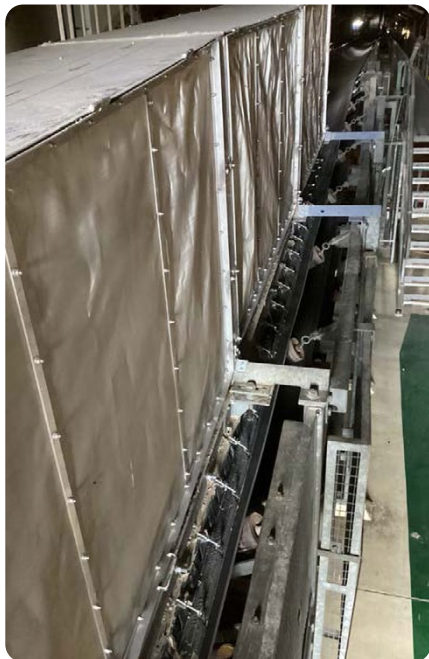
AirScrape and DustScrape combination eliminates dust and spillage plus the fire and explosion risks at the transfer chute load zone is greatly minimised.

AirScrape® and TailScrape, highly effective contactless skirting solution makes no contact with the belt surface with its unique diagonal arrangement of hardened lamellas, air is led from the outside into the middle of the belt, creating a powerful suction effect enabling fine dust particles to remain in the conveyor section.
