CASE STUDY

DIFFICULT CLAY AND SAND TRANSPORT UNDER CONTROL

Leading brick manufacturer in Brisbane, Australia, was faced with significant dust and spillage problems when transporting clay and sand.

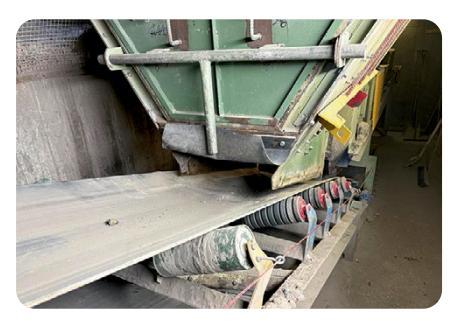
Before installation: excessive dust and spillage increased clean-up efforts and reduced overall.

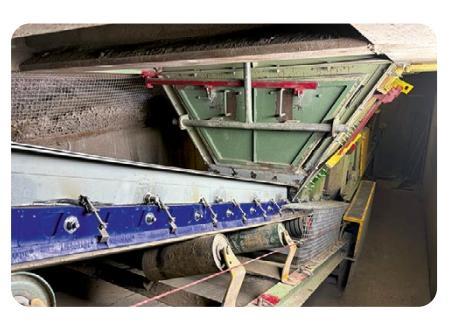
After installation: Dust and spillage reduced by 95% + after installing AirScrape®, TailScrape & K-Containment® Seal

The newly installed system significantly improved material containment and dust control. The maintenance supervisor reported a 95%+ reduction in dust and elimination of spillage, allowing the team to focus on more critical maintenance tasks.

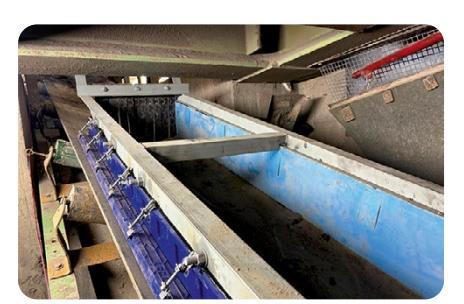
Transfer Point with installed AirScrape® and K-Containment® Seal.

A 4-metre-long, non-contact side sealing system designed to prevent spillage and reduce dust at the conveyor transfer points. By utilising a unique air flow design, AirScrape® creates an inward suction effect that contains fine dust particles while allowing bulk material to flow efficiently.

A 4-metre sealing system placed inside the chute to contain material drop and flow. This seal ensures that material remains within the transfer point, reducing spillage and maintaining the efficiency of material movement through the conveyor system.
